Practical Guidelines for the Inspection and Repair of Hot Dip Galvanized Coatings

Information courtesy of: HOT DIP GALVANIZERS ASSOCIATION SOUTHERN AFRICA

Surface Conditions (SC)

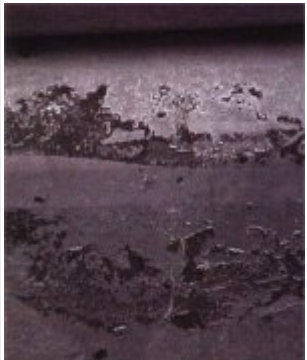
3	BARE SPOTS. Although excluded from ISO 1461, bare spots of about 5mm (2,2 x 2,2mm), due to small localised flows, are adequately protected by the sacrificial properties of zinc and will have very little effect on the service life of the coating. Where necessary, such spots may be repaired using one of the specified repair methods. Gross uncoated	There are several causes of bare spots. These include: Overdrying. If the time between fluxing and hot dip galvanizing is prolonged or the drying temperature is too high, the barrier protection provided by the flux may be lost. This is indicated by a rusty appearance on the ungalvanized article, which can result in coating discontinuities after hot dip galvanizing. G Excess Aluminium. A condition sometimes referred to as black spots may occur if the aluminium content of a bath becomes too high. No trouble should be experienced if flux concentration is correct and the aluminium content of the bath is maintained below approximately		A/R REP If necessary

areas are a cause for rejection. See Coating Repair Procedures.	0,007%. G Further causes are: Blowouts; flux deposits; stains and inclusions; mechanical damage; touch marks; uncoated surfaces caused by - surface contaminants, scale or sand; welds and weld spatter. See SC No's 6, 16, 19, 30, 33, 34, 35 and 37			
4	BLACK STEEL INSPECTION. Inspection prior to hot dip galvanizing is extremely important.	Components should be checked for distortion caused during rolling or fabrication. Check for appropriate vent, fill and drainage holes: removal of weld slag and spatter; venting of overlapping surfaces; unsuitable joining materials; temporary identification markings; clearance for moving parts and potential distortion due to the process.	Insufficient inspection prior to hot dip galvanizing can be the cause of dispute. G	A/R

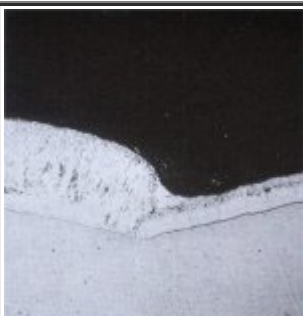
22	REACTIVE AND NON-REACTIVE STEELS, WELDED TOGETHER. Variations in coating thicknesses can arise when reactive and non-reactive steels are welded together. Efforts to increase coating thickness on the less reactive steel may result in an undesirably thick and brittle coating on the most reactive steel.	This difference in coating thickness, is brought about by a combination of a more reactive silicon killed steel, and/or high phosphorous resulting in a thicker coating and a less reactive aluminium killed steel, resulting in a coating thickness sometimes below that required in the specifications. Should the galvanizer be asked to	Select the same steel for fabricating a component. If need be, accept a concession request by the galvanizer when the thinner coating is possibly below specification. D/B	A/N

regalvanize in accordance with the specification, the resultant coating thickness on the reactive steel will be excessively thick, resulting in a brittle coating more susceptible to damage.			
23	REMOVAL OF ZINC COATING BY EXCESSIVE CLEANING. Unless otherwise agreed, the galvanizer will limit cleaning of the final coating by mechanical means to that required in the specification.	Excessive cleaning of the coating, particularly the edges, by mechanical methods, can result in uncoated areas.	The affected areas usually only appear after the component is installed. Care should be exercised by the galvanizer to avoid over cleaning. G/B	R REP At the galvanizer or alternatively at site
